**Archaeological Watching Brief Report
St John Sub Castro Church
Lewes, East Sussex, BN7 2QA**

**ASE Project No: 7941
Site Code: JTS16
ASE Report No: 2017409
OASIS id: archaeol6-296544**

This report presents the results of an archaeological watching brief carried out by Archaeology South-East at St John Sub Castro Church, Lewes, East Sussex between 24/07/2017 and 02/08/2017. The fieldwork was commissioned by Carden & Godfrey Architects in advance of the installation of drainage in the churchyard.

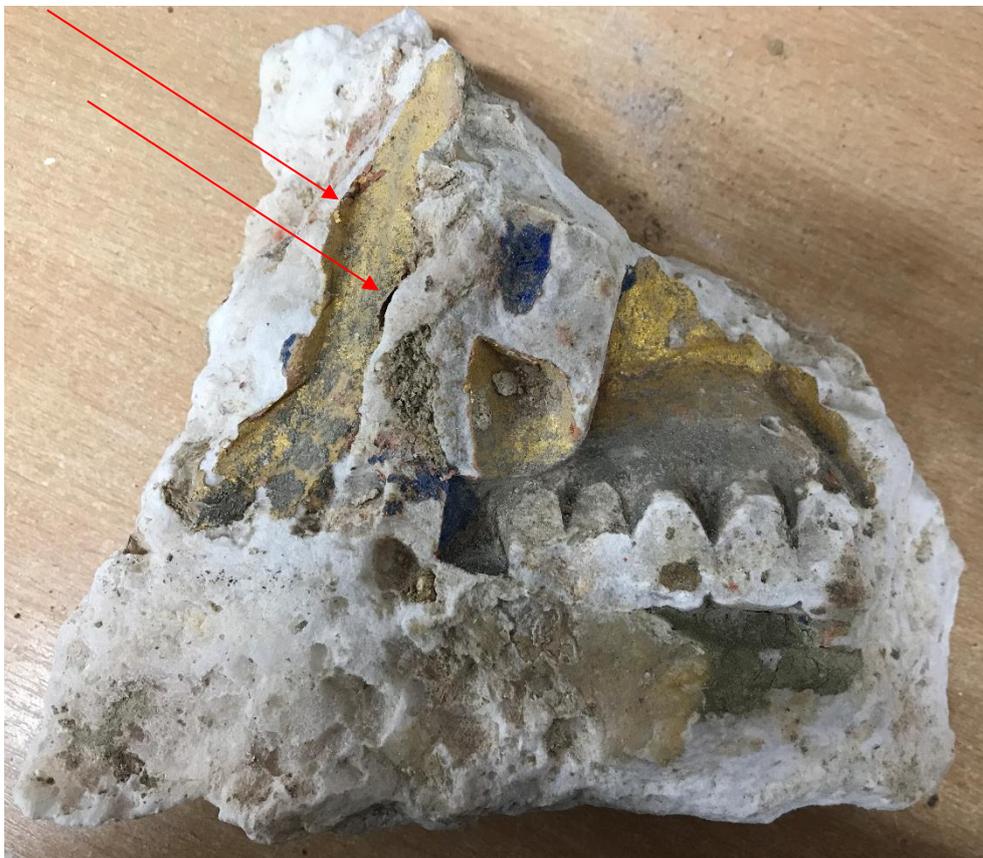
Plate 1: RF <1>

5.8.4 The piece depicts the bare right foot alongside folds of drapery. The toes are missing and the foot appears painted in a pinkish pigment while the top of the foot is covered with the hem of a dress or skirt, gilded over a mid- red ground. Parts of the cloak are painted in dark blue and/or gilded, and other colours may also be visible. This colouring suggests the sculpture originally depicted the Virgin Mary, or possibly St John the Baptist who is also often depicted wearing a blue cloak.

- 5.8.6 It is recommended that the fragment be both conserved (see 5.9) and also investigated by a specialist due to its significance to the history of St John sub Castro church. In addition, the object could be a rare example of surviving painted medieval alabaster sculpture; most remaining examples having lost their painted decoration.

- 6.5.1 It is recommended that the painted stone statuary, probably part of a larger work, be further conserved and studied by a specialist in medieval church statuary to address questions relating to its date, form and origins. Should this work be required, estimated costs can be provided upon demand.

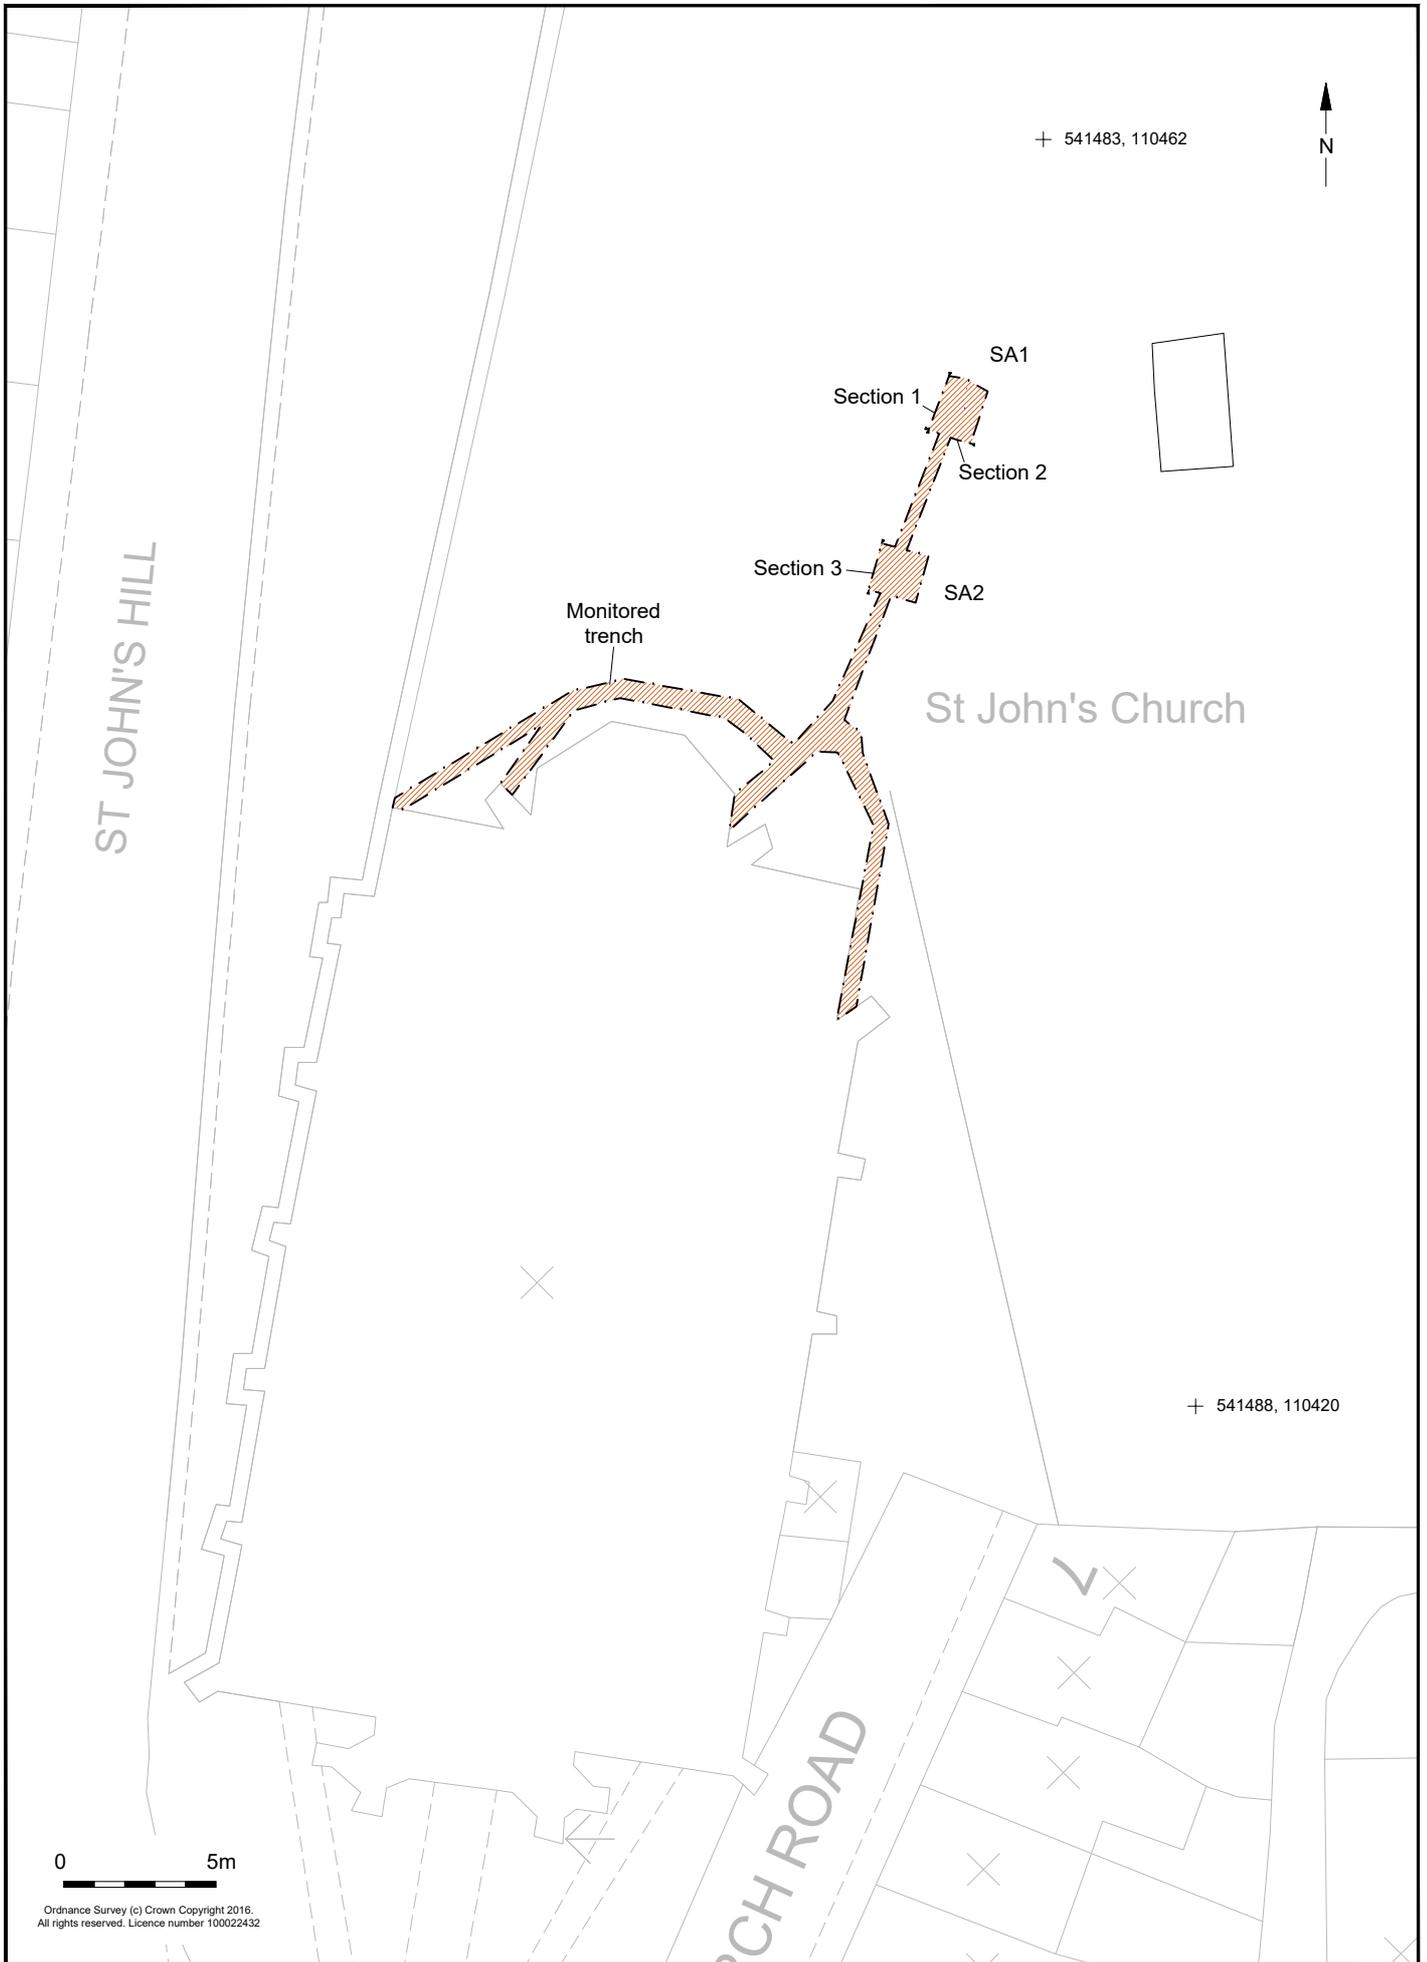
© Archaeology South-East		St John Sub Castro Church, Lewes, East Sussex	Fig. 2
Project Ref: 7941	September 2017	Watching brief location	
Report Ref: 2017409	Drawn by: AR

- 3.1.1 The soakaway and pipe trench were excavated generally in the proposed locations though there were slight alterations to the placement of the soakaways, and two of the drain runs had not been included in the original plans (Figure 2).

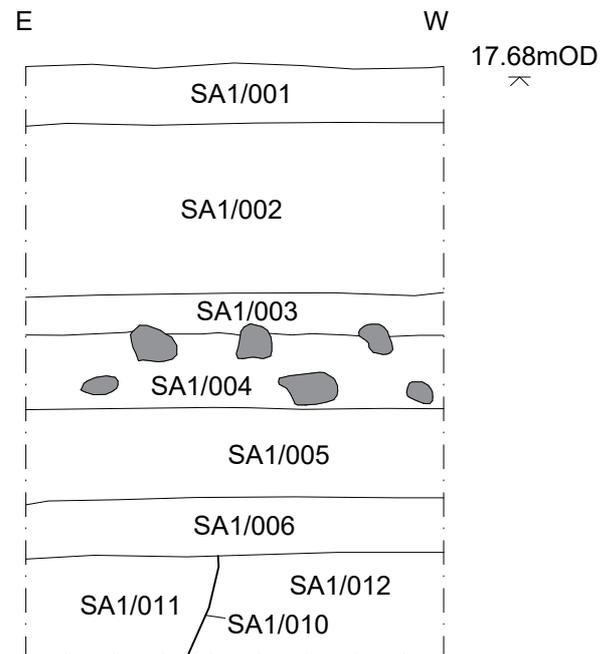
Section 1

Section 2

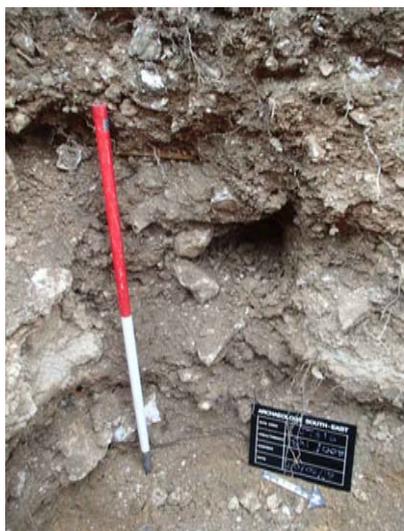
- 4.2.10 A disturbed grave cut [SA1/008] was identified in the vertical face of the soakaway. It was sharply cut through [SA1/002], [SA1/003], [SA1/004], [SA1/005] and [SA1/006] and sealed by [SA1/001]. It was backfilled with [SA1/009] a loose, friable mid to pale greyish brown silty clay. It contained chalk nodules and disarticulated human bone.

SA1/008, grave cut, looking west

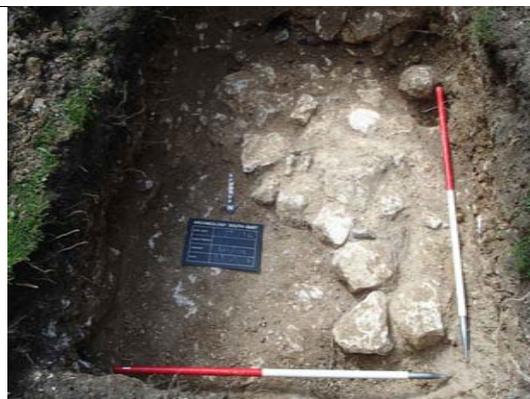
SA1/004, compact rubble looking south

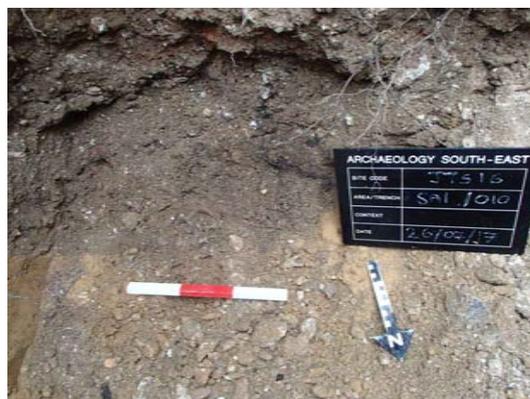
- 4.2.3 At the base of the excavation there was a pale orange clay [SA1/012] which *potentially* comprises an undisturbed natural deposit.
- 4.2.4 A pit [SA1/010] was identified in the vertical face of the soakaway and sharply cut into [SA1/012]. It was not fully excavated as it mostly lay outside the soakaway. It was filled by [SA1/011], a moderately friable mid greyish brown silty clay that contained occasional chalk flecks, charcoal flecks and burnt CBM. There was a single piece of 11th or-12th century medieval pottery recovered.

SA1/010, pit, looking south

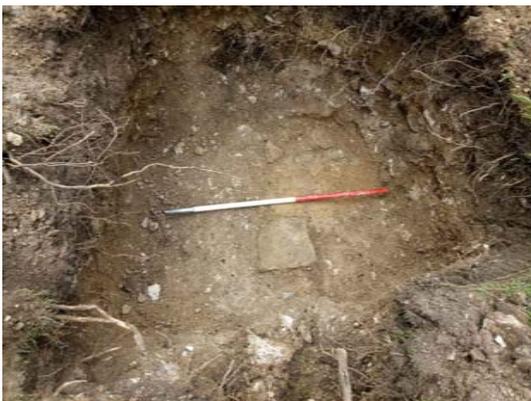
SA2 Masonry within backfill, looking north

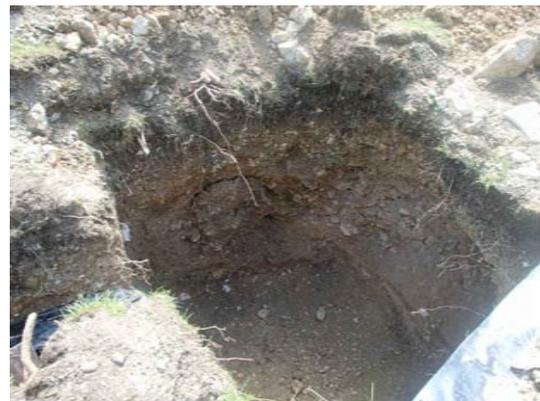
SA2 backfill deposits

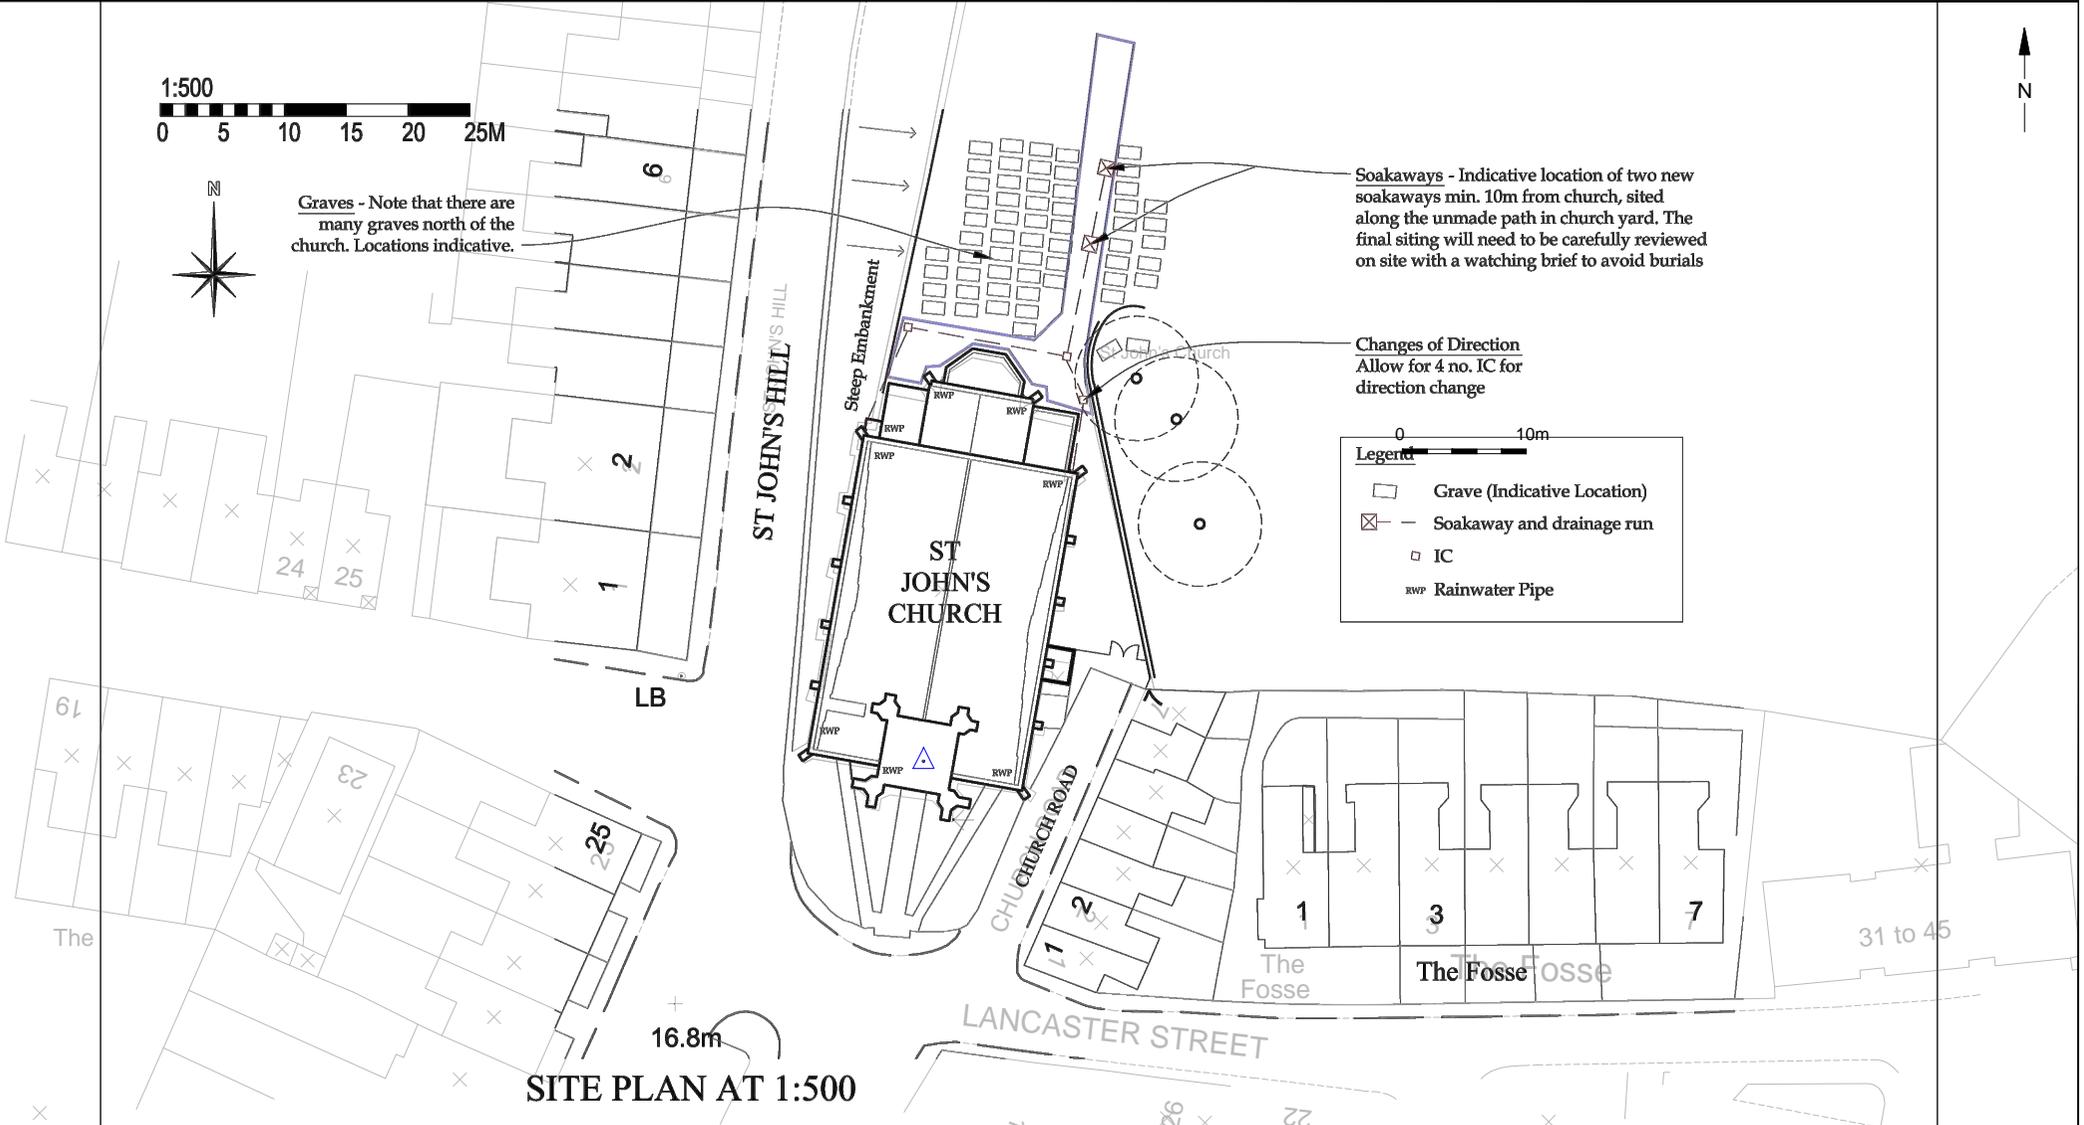
© Archaeology South-East		St John Sub Castro Church, Lewes	Fig. 2
Project Ref: 7941	April 2016	Plan of proposed drainage	
Report Ref: WSI	Drawn by: JC

SITE PLAN AT 1:500
